Buffet Induced Structural/Flight-Control System Interaction of the X-29A Aircraft

April 1991

David F. Voracek and Robert Clarke
Dryden Flight Research Facility, Edwards, California

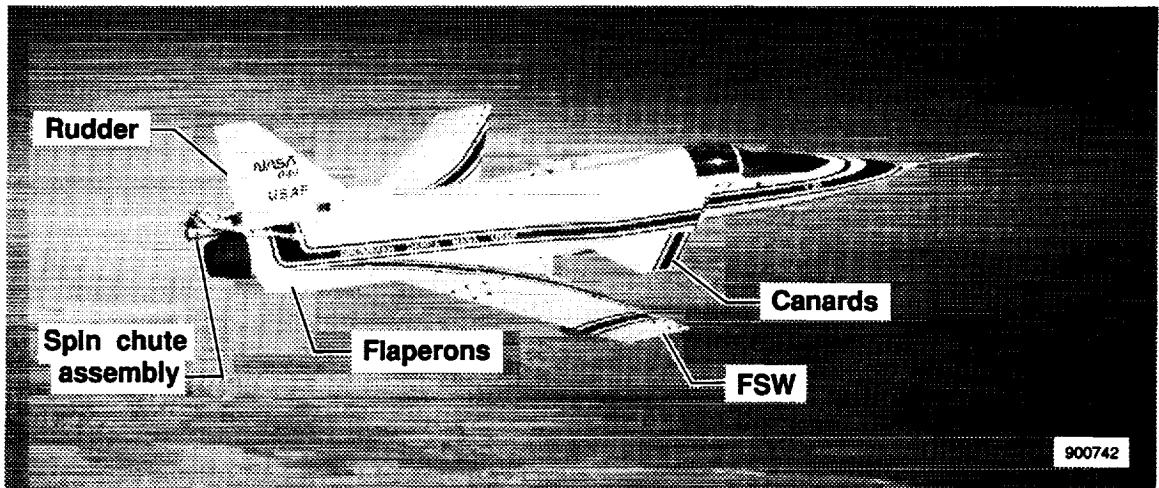
The X-29A (Fig. 1) incorporates many new technologies, the most evident of which is the forward-swept wing.⁸ The wing is made up of aeroelastically tailored advanced composite wing skins which have been designed to avoid structural divergence and ensure structural integrity within the flight envelope. Dual hinged trailing-edge flaperons provide both aero-

Figure 1. X-29A forward-swept wing aircraft.

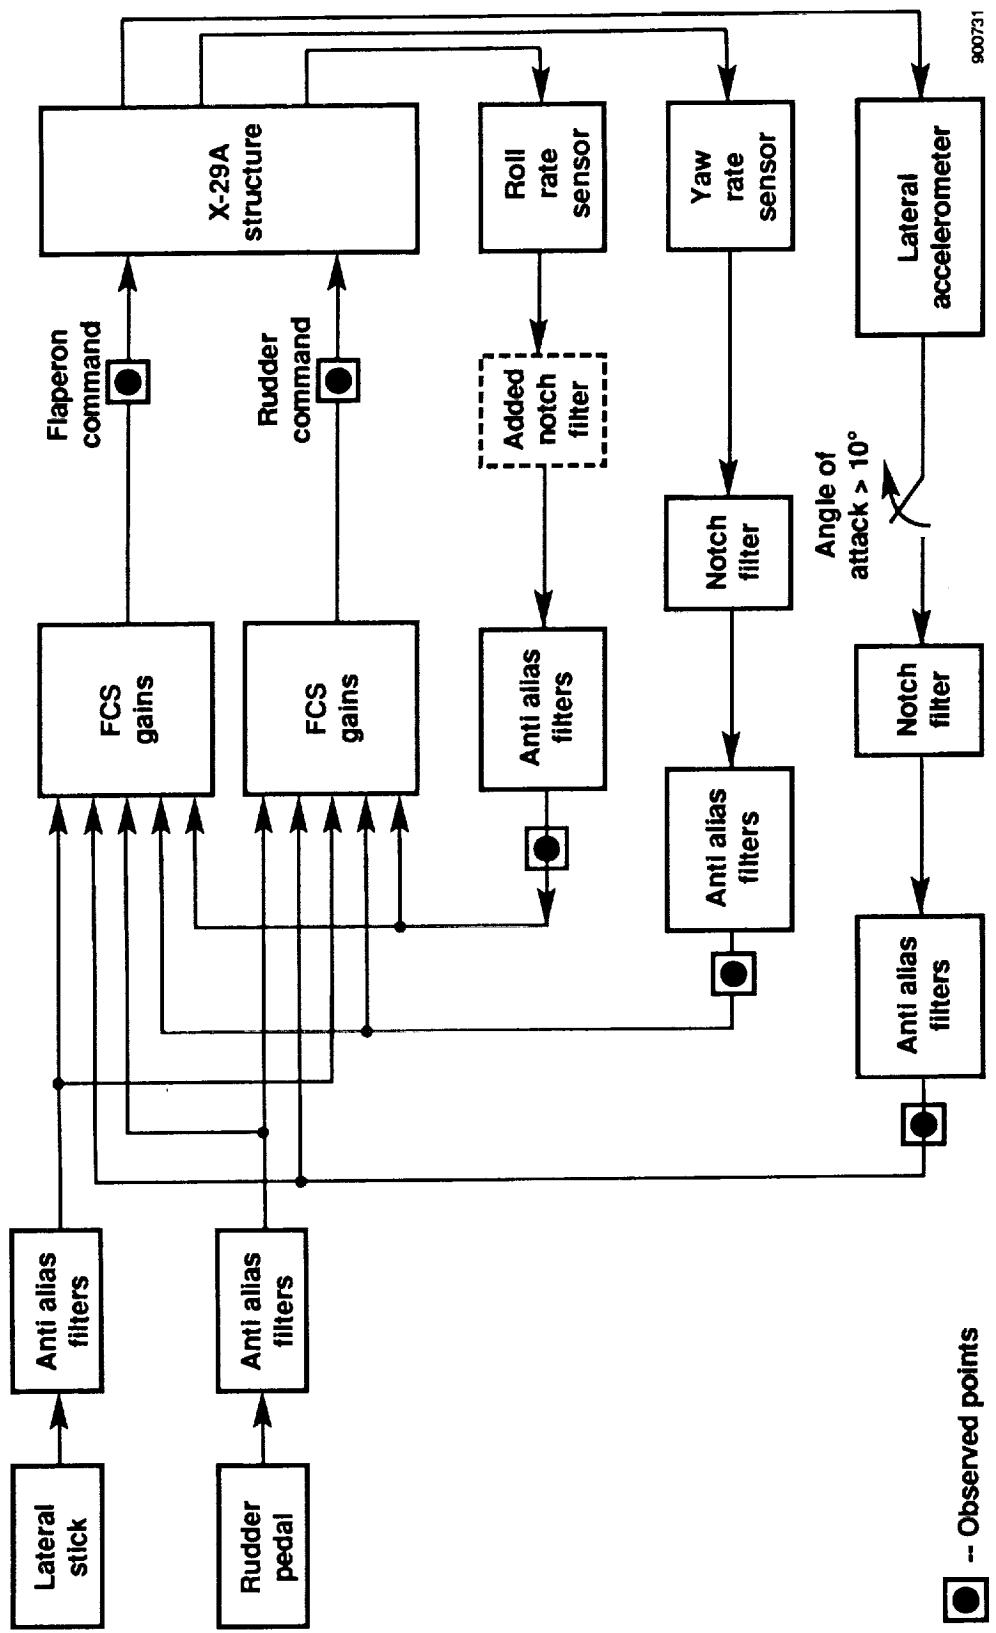
Figure 2. Simplified lateral-directional flight-control law block diagram for high-angle-of-attack flight.

This section provides a brief description of the high-angle-of-attack FCS lateral-directional axis, since it was this axis in which the ASE interaction was observed. Figure 2 is a simplified schematic of the lateral-directional control laws. The high-angle-of-attack lateral-directional flight-control laws use only the roll rate and yaw rate sensors for feedback signals above 10° angle of attack. Below 10° angle of attack lateral acceleration is also used as a feedback sensor.

The flight-control law gains are various functions of dynamic pressure, Mach number, altitude, and angle of attack. The flight-control computer (FCC) updates surface commands at a rate of 40 Hz. All of the sensor paths have anti-aliasing filters while only the lateral acceleration and the yaw rate paths have additional notch filters. The notch filters were provided for attenuation of the feedback signals at the critical structural resonant frequency of 11 Hz. The entire low-angle-of-attack envelope ($\alpha < 20$, $M \leq 1.48$, $h \leq 52,000$ ft) was cleared without the need for a notch filter in the roll rate path.

A notch filter was designed and implemented for the roll rate gyro path of the flight-control system (Fig. 2). The roll-off characteristics of the actuator system of the X-29A prevented this ASE interaction from becoming a limited amplitude oscillation or an ASE instability.

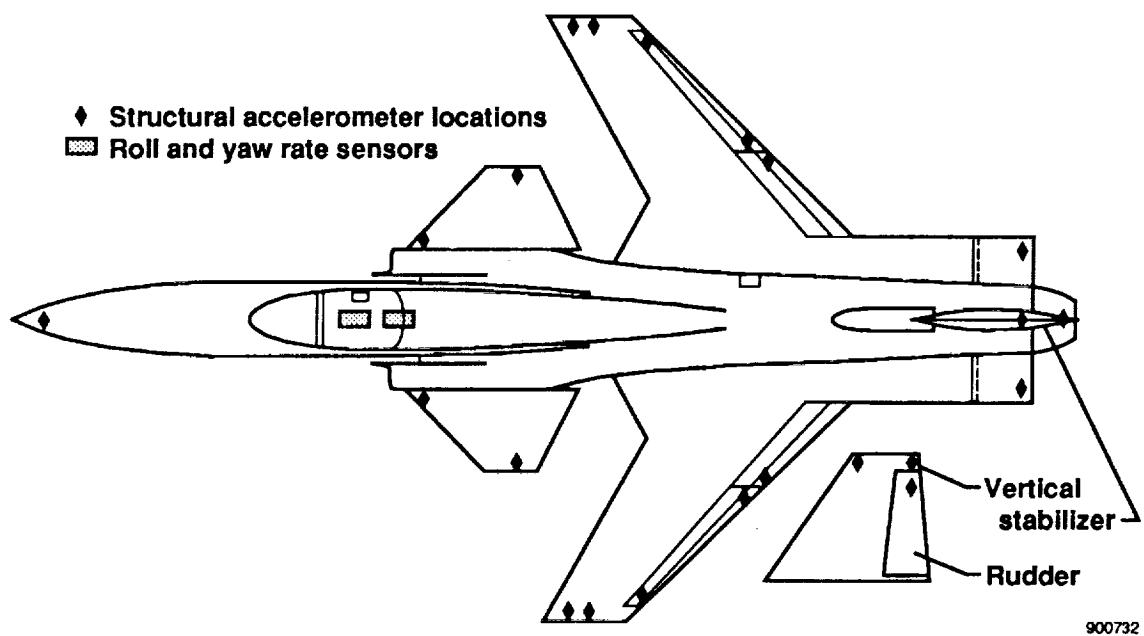
The aircraft instrumentation which helped detect the interaction consisted of the structural accelerometers and flight-control system (FCS) parameters (rate gyros, lateral accelerometers, actuator commands, and position signals). The locations of the structural accelerometers and rate gyros are shown in Fig. 3. A digital data bus provided access to the flight-control computer commands and feedback path signals. The feedback signals were analyzed at the point after the analog signal is digitized and the command signals

Figure 3. Accelerometer and rate sensor locations.

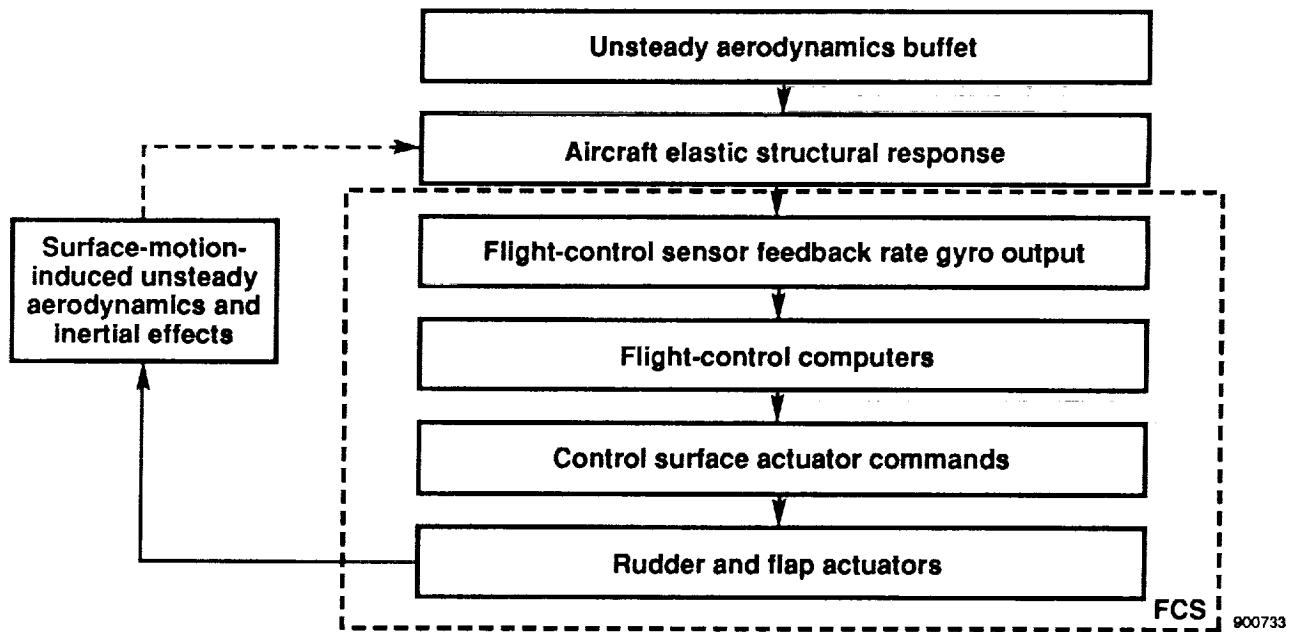
Figure 4. Structural interaction flowchart.

Figure 4 is a flowchart showing structural interaction. The flowchart follows the interaction from the aircraft's response caused by the buffet through the flight-control system to the aircraft's control surfaces. Each aspect of the interaction will be discussed in the following sections using data from selected structural accelerometers and feedback sensors. All the PSDs shown are at an angle of attack of 30°, which was the angle of attack at which the buffet amplitudes peaked and started to level off.

The small displacements of the rudder and flaperon would slightly affect the unsteady aerodynamics. This displacement would only produce a small amount of additional structural excitation because of the small rotational inertias of the control surfaces. In addition, the control surface effectiveness is reduced because of the low dynamic pressure flight conditions which again result in little structural excitation. The control surface-induced unsteady aerodynamic excitation was washed out by the high buffet excitation on the aircraft. As a result, the aerodynamics which are needed to sustain or cause a limited amplitude oscillation of the vertical stabilizer are not present in the interaction. The absence of the aerodynamics creates an open-loop situation which means that the path represented by the dotted line in Fig. 4 is negligible in this case.

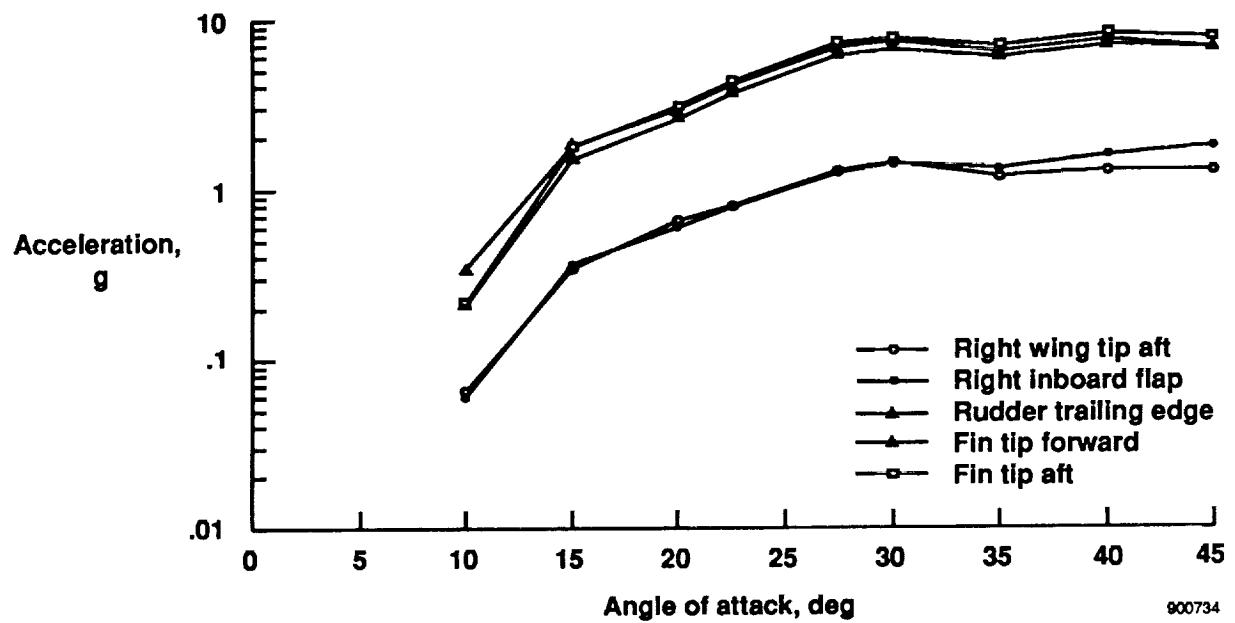
Figure 5. Modal power trends in aircraft structural accelerometers.

As the aircraft's angle of attack increased, the intensity of the buffet on the vertical tail also increased. The increased buffet intensity caused an increase in the structural dynamic response of the airframe. This increase in dynamic response with angle of attack is shown by the modal power plots for selected structural accelerometers in Fig. 5. Increases in the airspeed also added greatly to the dynamic response as shown in the accelerometer data Fig. 6. In Fig. 5, the modal power increases approximately one and one-half orders of magnitude between 10 and 30° angle of attack but remains fairly constant from 30 to 45° angle of attack. Also shown is that the vertical stabilizer dynamic response is greater than that of the wing tips. Figure 6 shows that the accelerometers on the vertical stabilizer were responding more to the increased buffet at the higher speeds than the wing tips and flaperons.

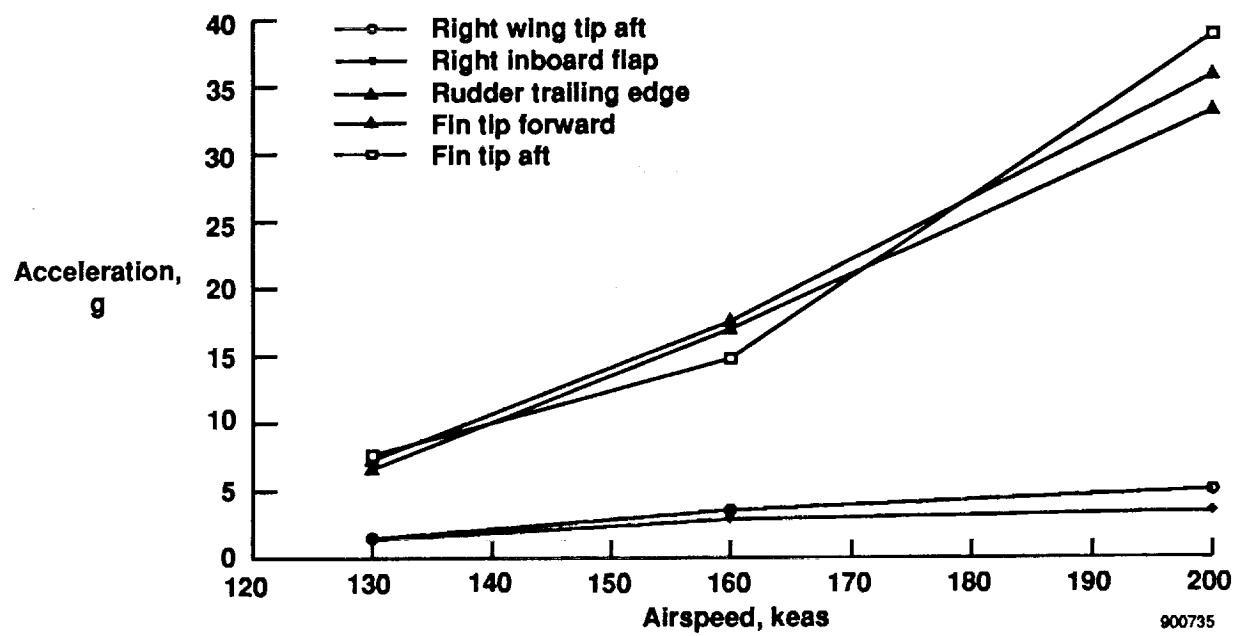
Figure 6. Modal power trends with airspeed in aircraft structural accelerometers.

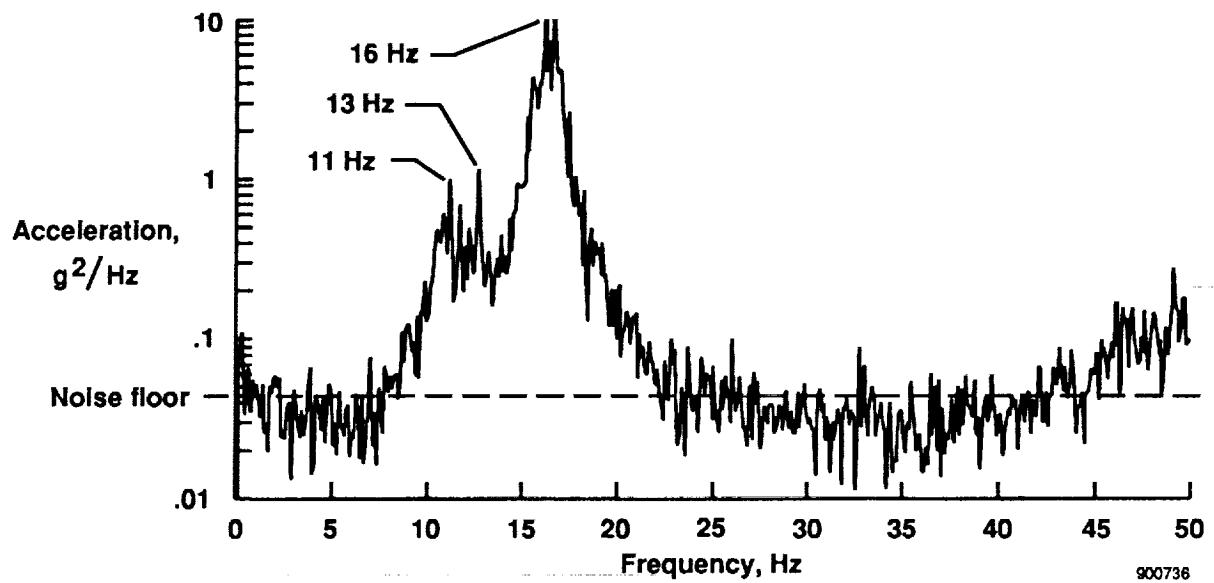
Figure 7. Power spectral densities of rudder accelerometer.

A PSD of the rudder trailing-edge structural accelerometer signal at 30° angle of attack is shown in Fig. 7. There are three major structural response frequencies in the data. The first two are at 11 and 13 Hz and their response levels are approximately one order of magnitude greater than the noise floor. The third peak is at 16 Hz with a response level two orders of magnitude greater than the noise floor. From the ground vibration test of the X-29A,¹¹ the 11-Hz mode had been identified as an antisymmetric wing bending, the 13-Hz mode as a fuselage lateral bending, and the 16-Hz mode as vertical stabilizer bending. These

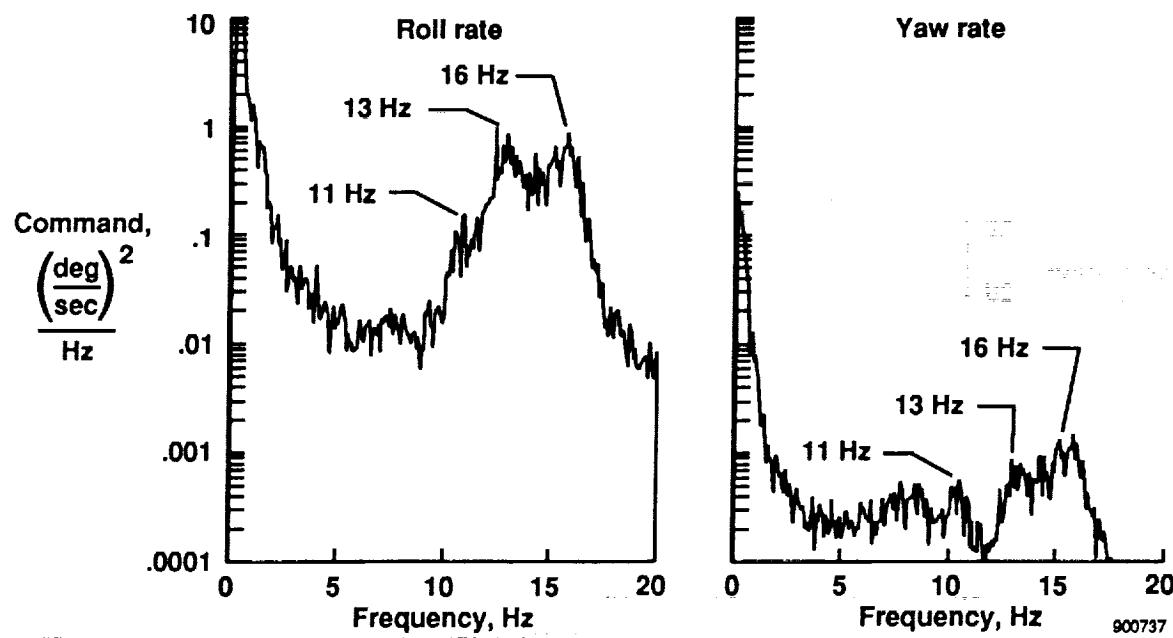
Figure 8. Power spectral densities of roll rate and yaw rate feedback sensor.

As a result of the increased buffet on the aircraft, the roll and yaw rate gyros also sensed the structural modes. The PSDs of the rate gyro outputs (Fig. 8) show a high amplitude roll rate feedback between 10 and 20 Hz with the structural response peaks at 11, 13, and 16 Hz. The yaw rate signal over the same frequency band and flight conditions is approximately three orders of magnitude less and does not appear to be significant, which may be partially attributed to the additional notch filter at 11.2 Hz in the yaw rate path. The flowchart in Fig. 4 shows that the output from the rate gyros is sent through the flight-control system where the flight-control laws amplify the signal, then send it out as commands to the actuators.

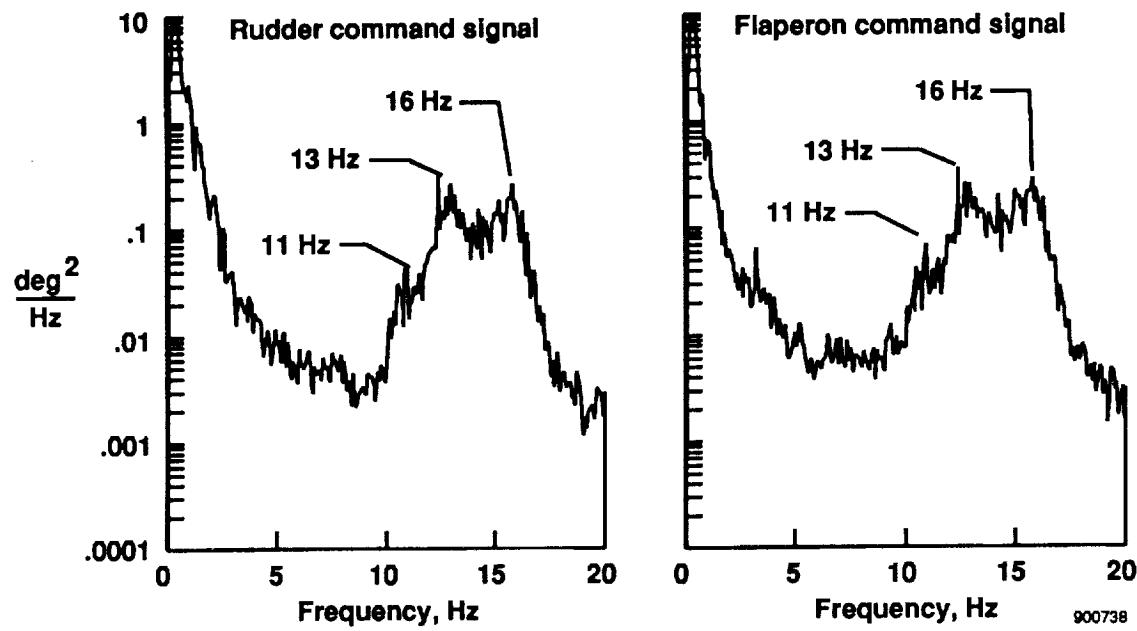
Figure 9. Power spectral densities of rudder and flaperon actuator commands.

The high amplitude roll rate feedback signal is now being commanded to the rudder and flaperon surfaces by the FCS. The PSDs of the flight-control computer commands to the rudder and flaperon channels are shown in Fig. 9. The rudder and flaperon command PSDs along with the roll rate signal PSD (Fig. 8) show similar frequency content. The structural resonant frequencies at 11, 13, and 16 Hz are apparent and the modal power trends are similar to the aircraft structural accelerometers shown in Fig. 5.

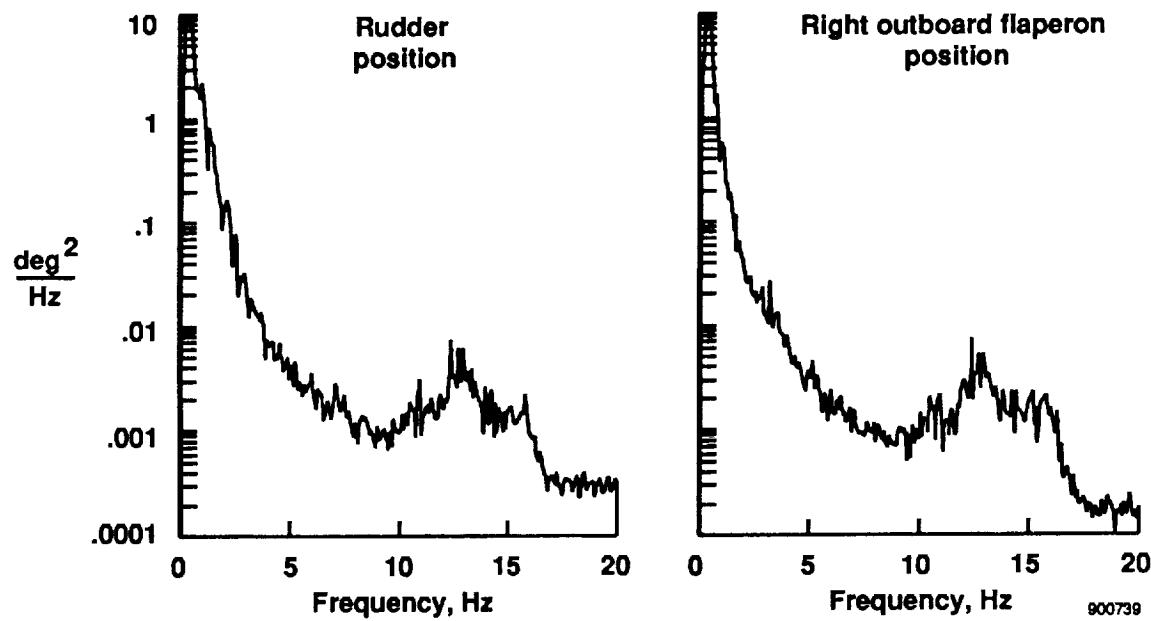
Figure 10. Power spectrums of rudder and flaperon positions.

The roll-off characteristics of the rudder and flap actuators, coupled with the rotational inertias of the control surfaces, tend to attenuate much of the actual control surface response at the high frequencies. The PSDs of the rudder and outboard flap position, shown in Fig. 10, still retain control surface response to the high frequency commands between 10 and 20 Hz. The resonant frequencies at 11, 13, and 16 Hz are again apparent. The relative amplitude of the position signal is approximately two orders of magnitude less than the amplitude of the commanded signals in this frequency band (Fig. 9). At and above 30° angle of attack the rudder and flaperon displacement were from ± 0.2 to ± 0.4 ° shown by the modal powers in Fig. 11.

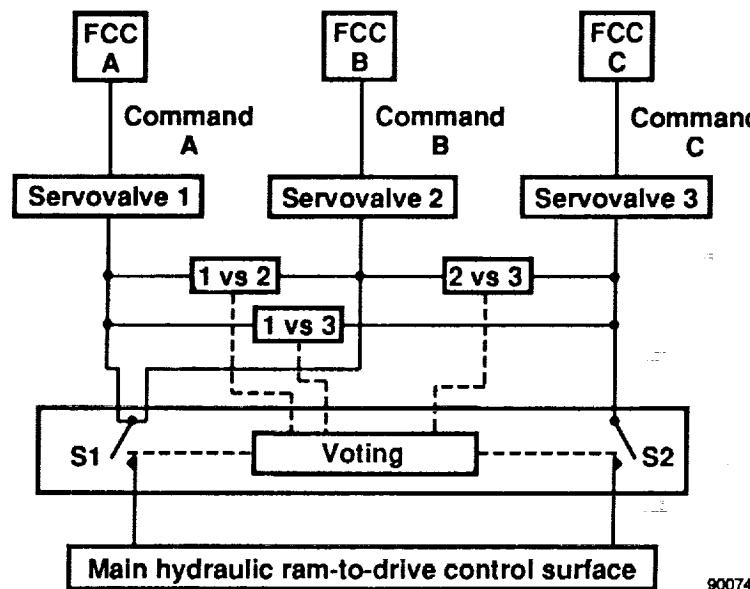
Figure 12. Servoactuator hydraulic schematic.

Although this interaction did not produce an instability, an adverse effect of the feedback interaction occurred during the higher speed maneuvers while the aircraft was flying at 30° angle of attack or above. The servoactuator was reconfigured and a servoactuator failure annunciator light was illuminated during the flight-test point, caused in part by the increased surface activity as shown in Fig. 6. A schematic of the servoactuator hydraulic system is shown in Fig. 12. Each actuator, controlled by three independent servovalves, operates one surface. Each servovalve receives a signal from one of the three FCCs. The hydraulic output from the servovalves is sent to a hydraulic voting block to compare the three outputs. If the servovalve output pressures agree within the specified limits, the average signal from servovalve one and two is used as the command to the actuator power ram (S1 is closed in Fig. (12)). If any of the servovalve output pressures do not agree, the servoactuator is reconfigured and a warning light is illuminated in the cockpit. An error in servovalve 1 or servovalve 2 results in a reconfiguration consisting of using the signal from servovalve 3 to generate actuator commands (S2 is closed in Fig. (12)).

The high-amplitude roll rate signal commands in the 10- to 20-Hz frequency range may have caused the servoactuator reconfiguration. These high-frequency

commands were outside the actuator's response capability. The first servoactuator failure caused the flight test to be terminated. In later flights, the actuators were reset inflight, and the point was repeated until it was successfully flown without a servoactuator failure indication. The long-term effects of the commanded high frequency signals on the actuators is unknown at this time.
